BLUE BIRD

R11SZ

DATE: JUNE 23, 2011

**SUBJECT: RECALL R11SZ BRAKE ABS MALFUNCTION INDICATOR LIGHT
NONCOMPLIANCE**

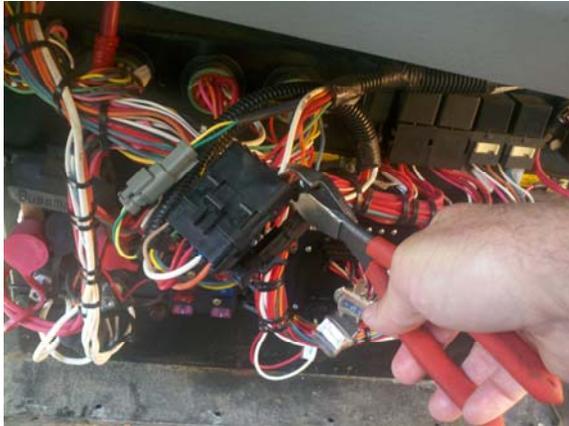
4. Locate connector C504 in PDU (detail shown below). Cut and remove connector C504 from the PDU and ABS harness.

5. Splice each circuit from previous step to the corresponding circuit. Use appropriate terminal as listed below.

C504	
ABS IGN (OR)	>A>	ABS IGN (OR)
ABS GND (WH)	>B>	ABS GND (WH)
ABS BAT (RD)	>C>	ABS BAT (RD)
MOD PMP BAT (RD)	>D>	MOD PMP BAT (RD)
ABS LGT (GN)	>E>	ABS LGT (TN)
ABS ACTIVE + (GN)	>F>	ABS ACTIVE + (TN)

Remove two “C504” connectors and splice each circuit to the corresponding circuit.
