DATE: DECEMBER 28, 2012
TO: U.S. DEALERS
SUBJECT: RECALL R12VT DRAG LINK CASTLE NUT TORQUE

Drag Link Castle Nut Torque

Models Affected: Certain 2013 Model Year Blue Bird Visions

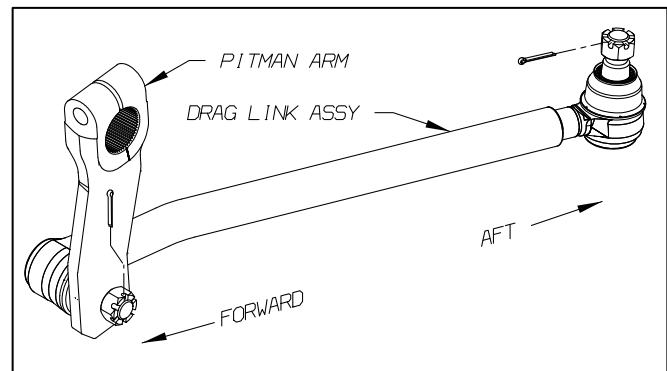
Fig. 1

The castle nuts on both ends of the drag link assembly may not have been installed according to manufacturer's installation specifications.

1. Park bus on a level surface, apply parking brake, switch engine off, remove ignition key and chock wheels.
2. Remove cotter pin from ball stud on forward (pitman arm) end of drag link. (Fig. 1)
3. Torque castle nut on drag link ball stud to 160-170 ft-lbs.
4. Re-install cotter pin. If castle nut slot for cotter pin does not line up with through hole in ball stud, tighten castle nut until next slot aligns with through hole. Install cotter pin & bend-over pin tails.
5. Remove cotter pin from ball stud on aft (steer arm) end of drag link. (Fig. 1)
6. Torque castle nut on drag link ball stud to 160- 170 ft-lbs to fully seat ball stud in steer arm.
7. Loosen aft castle nut approximately 6-8 turns.

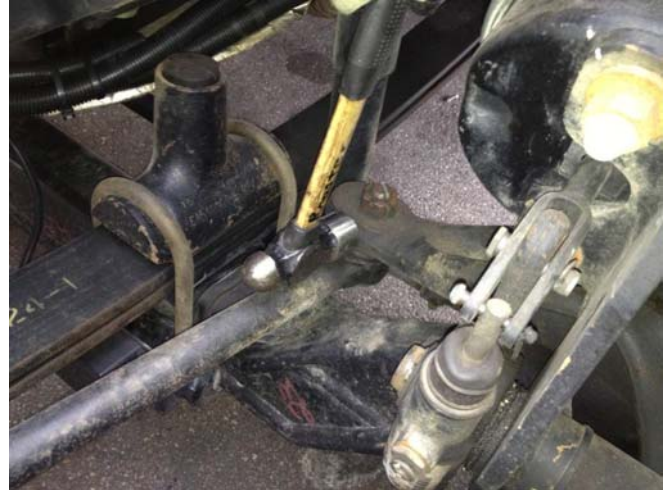
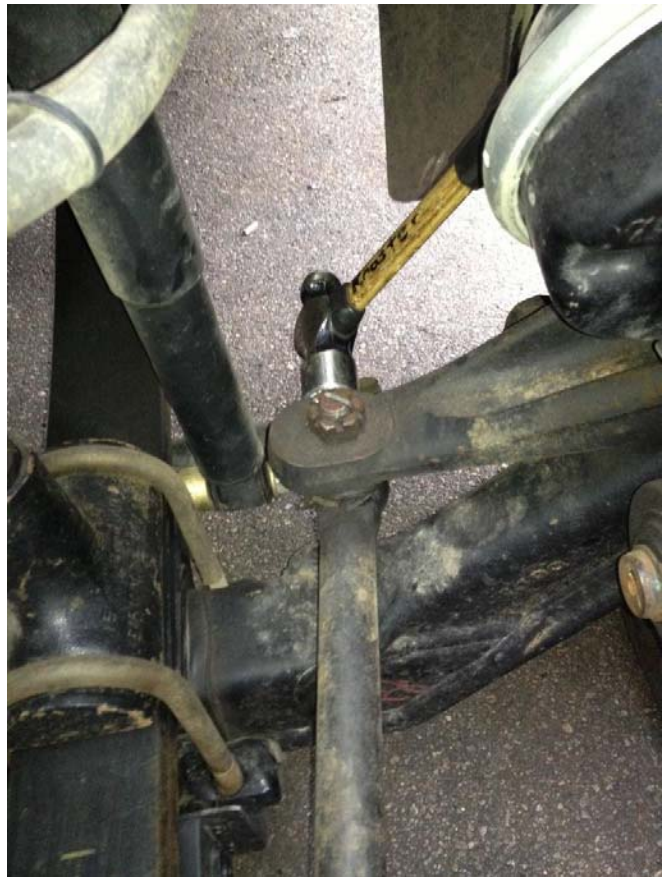
Fig. 2

- If ball stud taper drops out of steer arm after one or two blows, then steer arm tapered hole is damaged. Skip to step 13 and replace steer arm (upper steering knuckle).
- If ball stud taper remains firmly seated in steer arm after two blows, joint is ok.
- Torque castle nut on drag link ball stud to 160-170 ft-lbs.
- Re-install cotter pin. If castle nut slot for cotter pin does not line up with through hole in ball stud, tighten castle nut until next slot aligns with through hole. Install cotter pin & bend-over pin tails. This completes the corrective action.

- Using a 2 lb. ball peen hammer, strike sides of steer arm with two, firm, horizontal blows. Once in each direction. (Fig. 2 & 3)

NOTE: Castle nut on aft drag link ball stud **MUST** be torqued then loosened 6-8 turns before striking steer arm.
