All American Cowl Panel Repair

UPDATE

Body Models Affected: All-American (A3FE & A3RE)

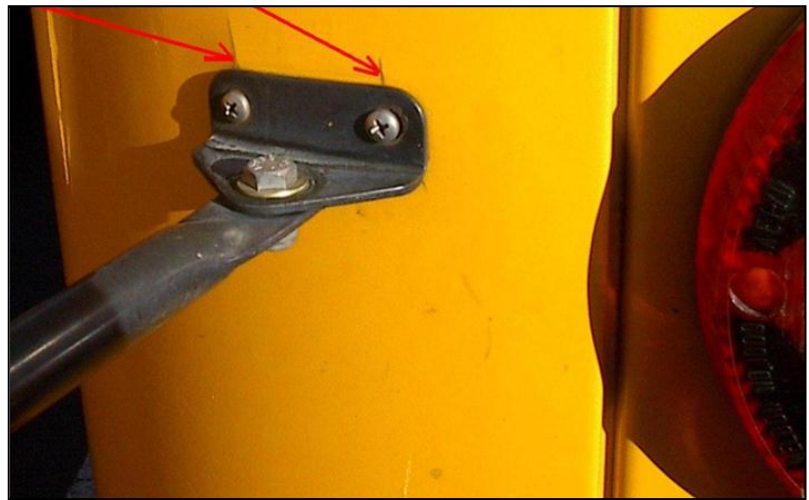
Under certain conditions you may experience a crack forming on the cowl panel where the crossview mirrors mount, reference photo. Perform the following procedure at each area where cracks have formed.

1. Disconnect the batteries, negative first, and then positive.
2. Remove the mirror mounting brackets.

NOTE: If the bus has heated mirrors you need to disconnect the wiring to prevent damage to the harness.

3. Stop drill the end of the crack with 1/8 inch bits.
4. Prep the cracked area for welding by removing the paint and notching a “V” groove along the crack.
5. Weld the crack solid from the mounting hole to the drilled stop hole.
6. Dress/grind welds down and flush with cowl panel surface as possible so that body work will be minimal.
7. Prep repair site and apply body filler as required.
8. Back drill the existing mounting holes with an 11/32 drill bit.
9. Install ¼ in rivnut (02001394).
10. Perform final prep, then spot paint and blend the affected area. Buff and finish as required.
11. Re-install mirror brackets using ¼ screws (02000701) as required.
12. Reconnect batteries, positive first then negative.
13. Place the bus back into service.
