BLUE BIRD

R11SZ

DATE: JUNE 23, 2011

**SUBJECT: RECALL R11SZ BRAKE ABS MALFUNCTION INDICATOR LIGHT
NONCOMPLIANCE**

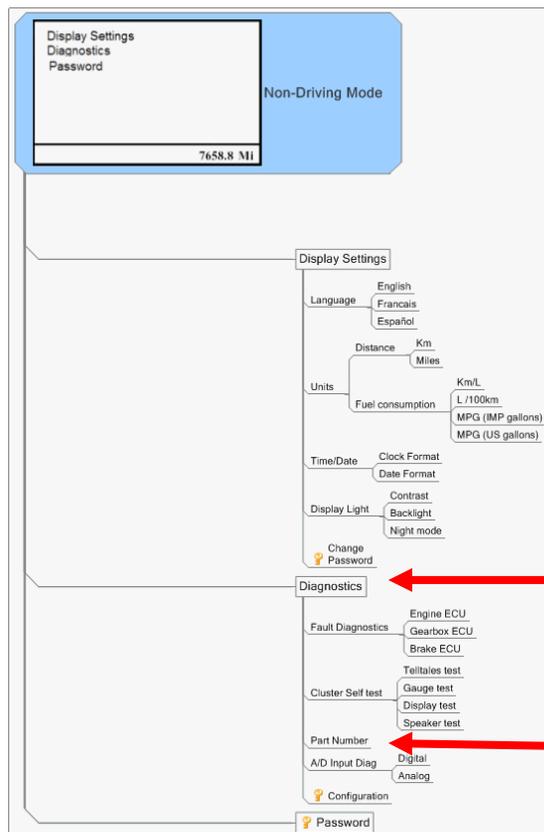
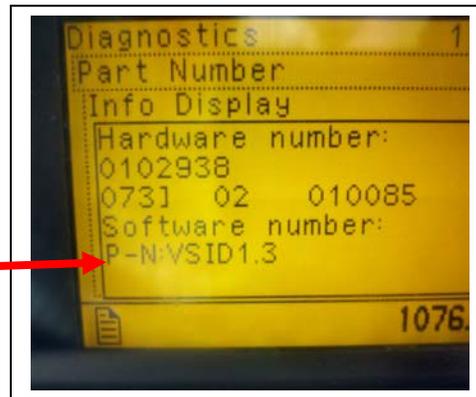
Step 2. Using steering column stalk switch and instrument cluster diagnostics menu verify current software version displayed under part number menu.

Step 3. On units with version 1.4 or lower software installed flash the instrument cluster with version 4.11 software provided. On units with version 1.5 or higher installed flash the instrument cluster with version 4.1 software provided.
